Urban Drainage Systems and Implications on the Inhabitants and Physical Environment of Buea Urban Area, South West Region of Cameroon

Abstract

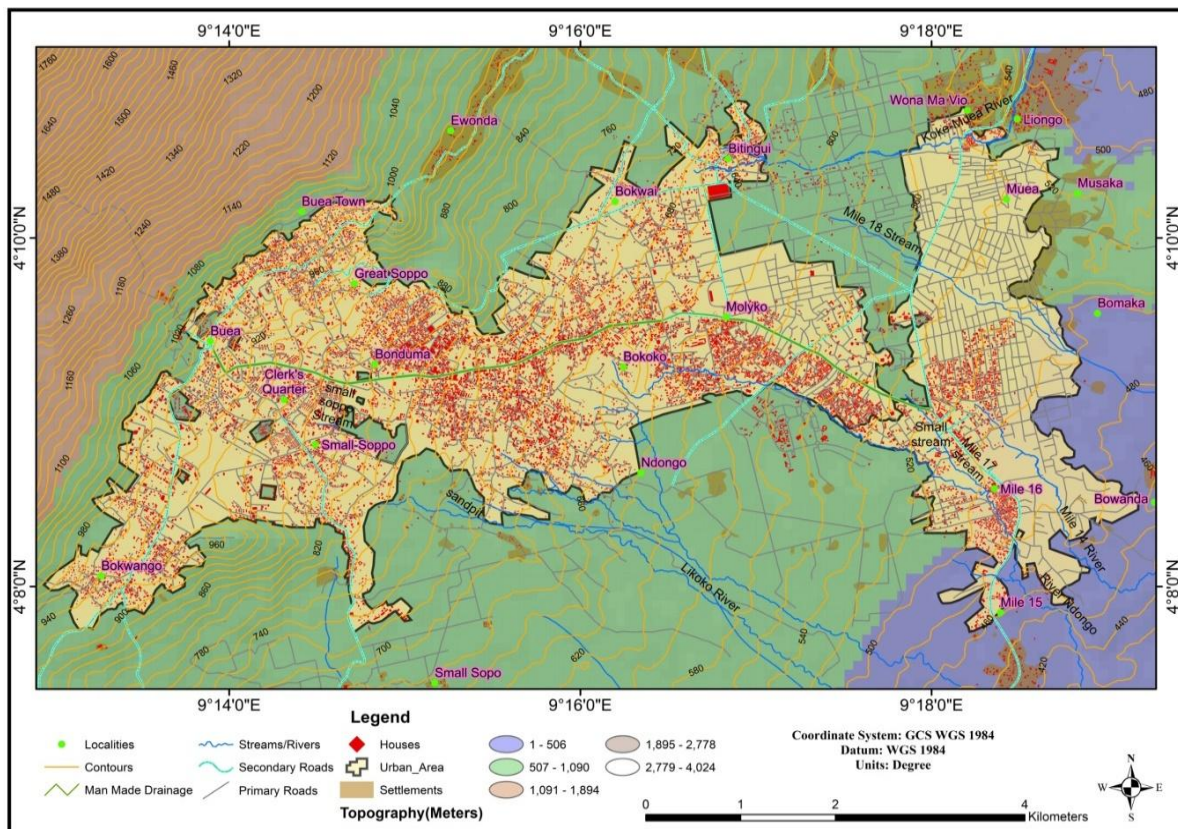
Figure 2: Drainage Pattern in the Buea Urban Area

To fully address the patterns of the drainage system within the Buea Urban Area, certain aspects were taken into consideration including the spatial distribution, structures and quality of drainage systems. However, to begin with, it is vital to present the spatial distribution of the main drainage system categories (Figure 2). On the landscape, natural drain systems consist of rivers and streams whose flow and movements are influenced by many factors including the geography of the environment and anthropogenic forces. Concerning the information presented in Figure 2 which depicts the nature of the urban drainage systems of Buea, the area is found on the slope of Mount Cameroon with intervening slope plates within some parts of the town such as the GCE Board and the Mile 17 areas. Naturally, the Buea urban area is well-drained. Four main river systems drain through Buea including the Likoko, Ndongo, Mile 18 and Kokoe streams which flow from the south towards to northern part. Based on the natural influence on drainage patterns, rivers take their rise from the mountain and rain downward passing through settlements like Soppo, Muea, Molyko, Mile 16 and Mile 17. The main watercourse is the Ndongo River, a stream that takes its rise from Mount Cameroon and flows downwards cutting

across Buea from Buea town, through Bonduma and Molyko to Mile 16. The other natural drains are the valleys of seasonal tributaries of the main drainage system.

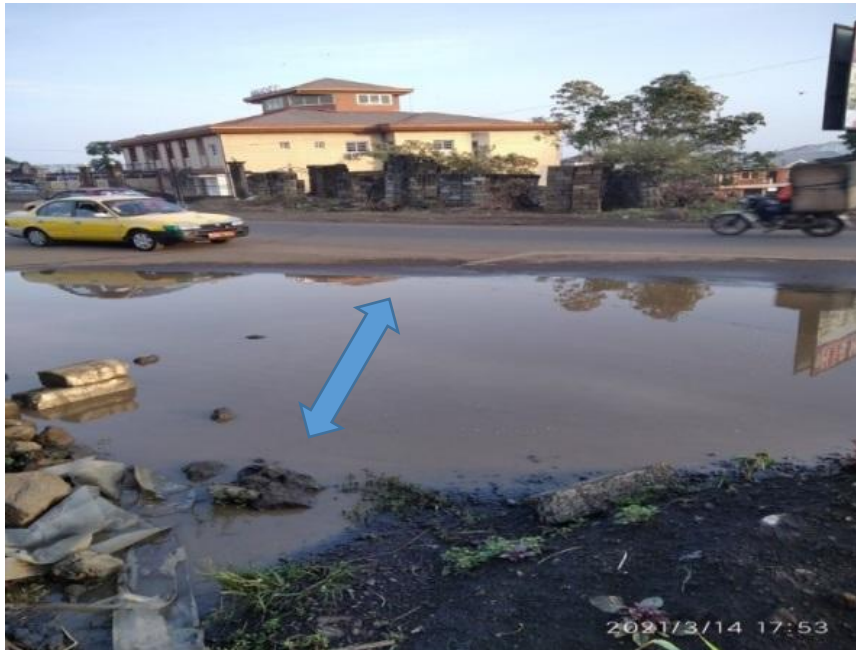
Plate 1: Lack of Drainage Infrastructure at Mile 17

From Figure 3, 25% of the respondents attributed that many of the drainage systems were too shallow, 20% of the sampled population also advocated that most of the drainage systems were very narrow while 18.3% claimed that they were not well designed. 15% confirmed that some of the drains contained fractures and the least were those who said that most of the drains were not well plastered. Field survey also revealed that areas with better drainage facilities were the University of Buea Campus and parts of the GRA premises, while areas with the worst drainage

facilities were found around the CGCE Board, Old Police Station in Molyko and part of Mile 17 car park as presented on Plate 1.

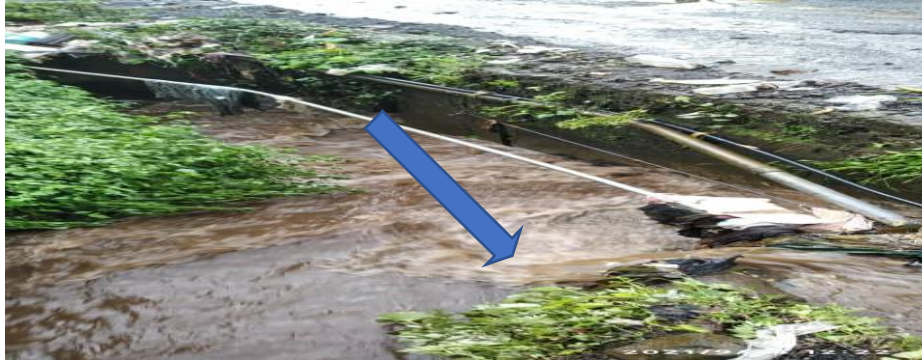
Plate 2: Water diverting from the Main drainage channel at Buea Town Neighbourhood

Figure 4 disclosed that 55% of respondents consider a greater part of the drainage systems in the Buea Urban Area as bad. Approximately, 12% of respondents confirmed that the drainage systems are good and the least were those who said it was the best as evidenced by 2% of the sampled population. Plate 2; shows the poor nature of the drainage systems along parts of the

Buea Main roads along the main road leading to Buea Town. The urban drainage systems within the Buea Urban Area are diversified with clear evidence that the different localities in the Buea Urban Area have different structures of urban drainage systems which are not up to standard in terms of quality, size and patterns.

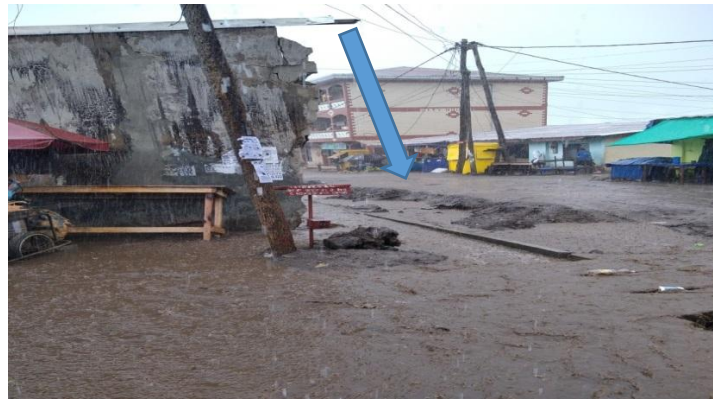
Plate 3: Evidence of Poor a Drain in Molyko Neighbourhood

Figure 5 presented a significant majority 25% of respondents noted poor waste materials deposited into gutters followed by 20% of them complaint about the tiny drainage system, 16.7% attributed the incidence to both poor planning of the town as well as houses which are usually sited on most drainage coverts. The least were those who stood for the heavy rainfall as supported by 1.7% of the exemplified population. Plate 3 indicates the tiny nature of drainage is the cause of water overflowing into unwanted areas as shown by the arrow. As such, this resulted in passage inaccessibility and the disturbance of activities carried out within the Buea Urban Area.

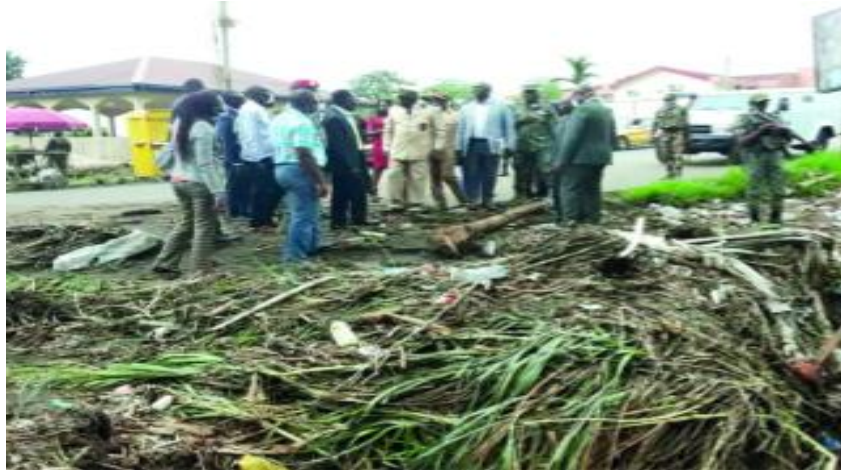
Plate 4: Heaps of Eroded Materials Deposited by Runoff around the Central Police Station at Buea Town supervised by the Municipal Authorities

Plate 4, shows heaps of waste materials deposited at the entrance to the General hospital after a heavy downpour which could not be contained by the drainage systems on March 08th, 2020. It also led to the destruction of the fence around the police station in Molyko due to head debris carried by runoff. Many houses were flooded with inundation runoff after the heavy downpour in the area with severe implications on many households properties and belongings especially in neighbourhoods along the Regional Hospital Junctions area stretching towards Memos Banquet Hall, and Part of Soppo, Bondoma and Buea Town, the Presbyterian Church Synods office area on the road to Buea Town, the Cameroon GCEB and the Government Technical School Campus in Molyko, the University of Buea Junction and the Mile 17 Round About.
